Re-tuning Case Study

Parmenter Re-tunes Las Colinas Tower for Significant Energy Savings. Irving, TX

ENERGY STAR score improves by nine points with Building Re-tuning training.

Address: 225 E. John Carpenter Frwy, Irving TX
 Owner: Parmenter Realty Partners Size: 349,436 sq ft.

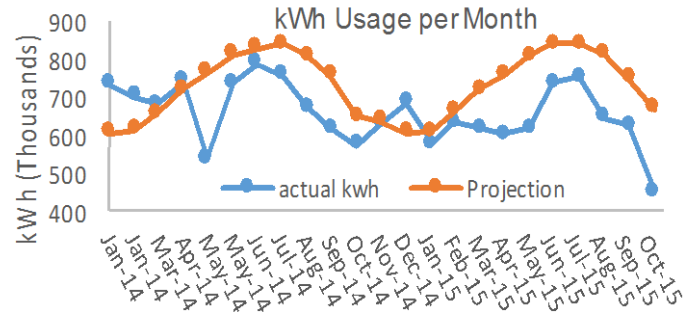
In the 2 years post-re-tuning, the building has saved an average of 9.7% on its electricity usage due to a long list of energy savings opportunities (details shown on following pages (Figure 1). Las Colinas Tower II also improved its ENERGY STAR score by 9 points from 70 to 79.

Figure 1. Projected kWh usage based on a year's monthly consumption prior to re-tuning and weather normalization.

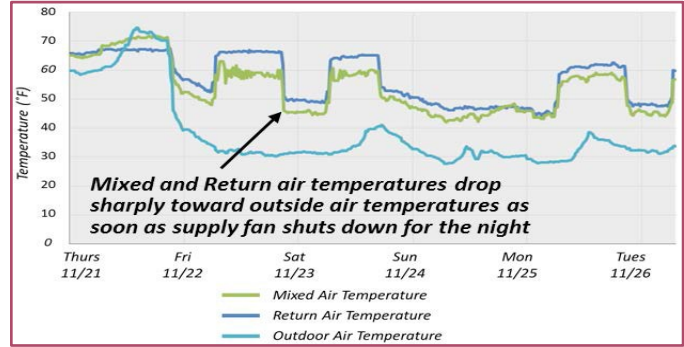
In Figure 2, the mixed air temperature (green line) and return air temperature (blue line) trended data readings both show patterns that may indicate the building is operating in a negative pressure condition at night (and perhaps even during the day). After the supply fan shuts down, both the mixed air and the return air temperature sensors immediately drop toward the outdoor air temperature value (teal line), in some cases dropping as low as almost 40 F. It appears that during the 6-day period in November, the return air temperatures progressively got cooler (possibly indicating that this building also got cooler). Perhaps the reheat system is not working properly, or some other issue exists such as

significant infiltration. This is a re-tuning efficiency opportunity that should be explored further to solve the root-cause of the data finding in Figure 2.

Figure 2. Trended Data Showing Return Air and Mixed Air Temperature Performance

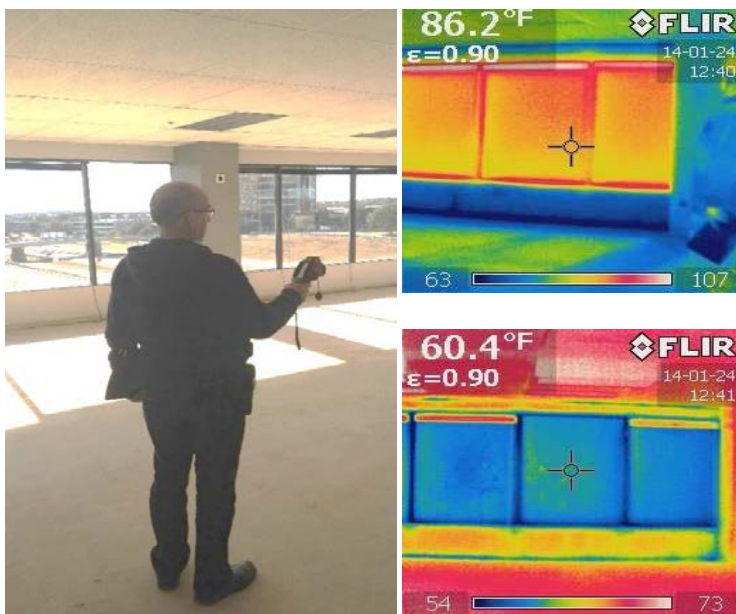
The window-to-wall ratio is significant (at least 80% or greater) in Las Colinas Tower II, meaning that solar loading significantly impacts the building. Using a thermal imaging camera (see Figure 3), a significant difference in window temperatures on the south and west sides of the building was identified. East, south and west-facing windows exhibit significant solar gains on cold, but clear days (morning low temperatures around 20 F, afternoon high temperatures around 45 F). This was creating interior temperatures between 75 F and 78 F at the perimeter spaces facing south. Re-tuning measures to consider for buildings to counter solar heat gain include:

Figure 3. A thermal imaging camera is used to identify solar load for south-facing (top) and west-facing (bottom) windows

- Send periodic messages to occupants via email to encourage the judicious use of window blinds during peak solar conditions.
- Turn perimeter lights off (where controls and switching allow) to reduce the heat gain from electric lighting loads (trade off the solar gain with the lighting heat gain or vice versa) or de-lamp where possible.
- Window tinting may be an effective investment, but should be carefully evaluated for correct tinting materials and installation methods to safeguard windows from damage

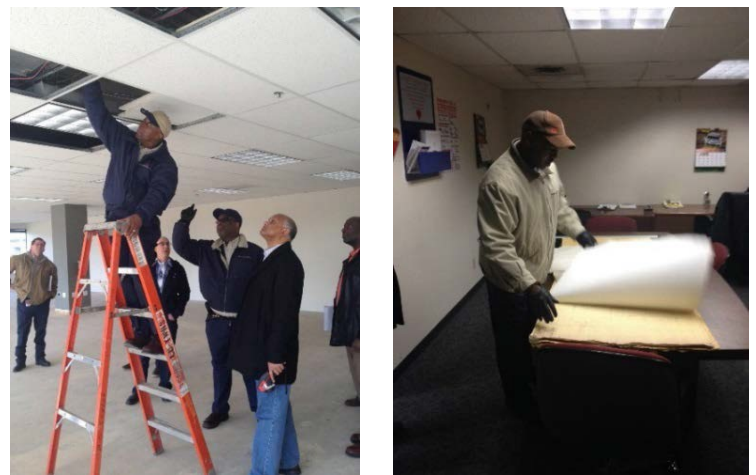
After the re-tuning training, the Las Colinas team decided to walk-down the building after hours. Operators found numerous inefficiencies: heat on after hours, task and break room lighting on while space was unoccupied, and terminal air fans running.

Figure 4. Building walk-down included checking above the ceiling for duct condition, etc. (left) and reviewing electrical and mechanical prints (right)

To solve this, they asked security to turn off all lights left on by tenants, and proposed installing electric to pneumatic (EP) switches on every floor to shut off all non-essential loads after hours.

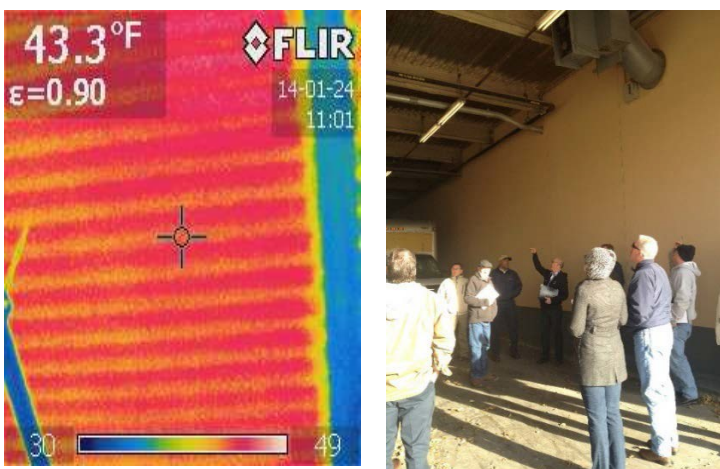
Figure 5 shows an infrared image of the Parmenter Las Colinas II loading dock ceiling, just below office space. The outdoor air temperature is 30 F while the ceiling temperature was measured much higher at 43.3 F. During the re-tuning training building walk-down, it was noted that the loading dock ceiling insulation may be lacking. This likely has resulted in heat loss/gain to the office spaces above, which could contribute to tenant hot/cold calls and energy inefficiencies.

Figure 5. A thermal imaging camera is used to examine the loading dock ceiling

Re-tuning opportunities include evaluating areas of missing insulation or poorly insulated/sealed locations in loading docks, parking garages, and similar areas open to the outdoors.

- Verify that initial garage parking lot area under office spaces is adequately insulated (hard ceiling with access panels). Suggest using an infrared camera image of the floor from above (looking down) if access issues are a problem.
- Seal penetrations of conduits and piping that route from loading dock areas into the building.
- Look for similar penetrations that may not be sealed on all perimeter sides of the building

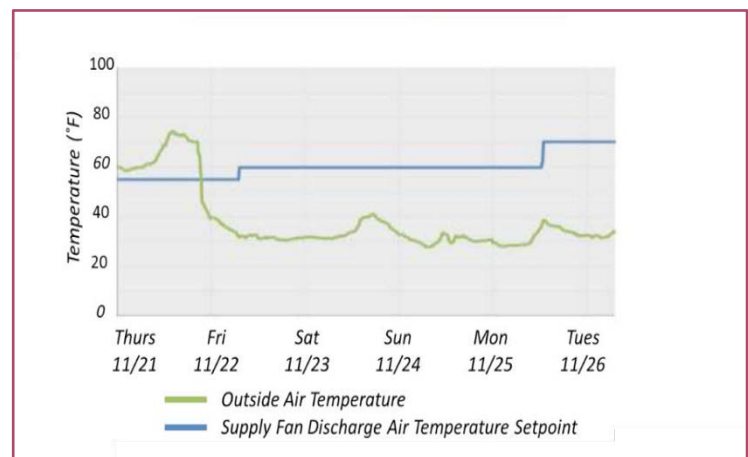
In Figure 6, the AHU discharge air temperature set point (blue line) appears to be manually adjusted, based on the staggered stair-step flat lines. The discharge air temperature set point in the control code was found to be reset automatically from the return air temperature with a secondary reset based upon the outside air temperature. Figure 6 hints at manual overrides being used, so perhaps the automatic reset values are too low.

Figure 6. Manual Override on AHU Supply Fan Discharge Air Temperature Set Point

- Use a return air temperature reset only (remove the secondary outdoor air temperature reset). The current reset operation is configured to reset between 70 F and 74 F return air temperatures, but the reset should be based upon the return air temperature operating between 72 F and 76 F. This schedule will lead to more comfortable conditions and will decrease the need for occupants/tenants to request overrides of the system schedule
- Reset the discharge air temperature (blue line) to be between 53 F and 63 F, a 5 F increase. The current operation is between 48 F and 58 F. With this increase, the supply air should still be cool enough to provide adequate cooling at the warmest zones and provide adequate moisture removal at the cooling coils. The existing reset parameters result in higher energy costs for cooling and subsequent reheating at the terminal boxes

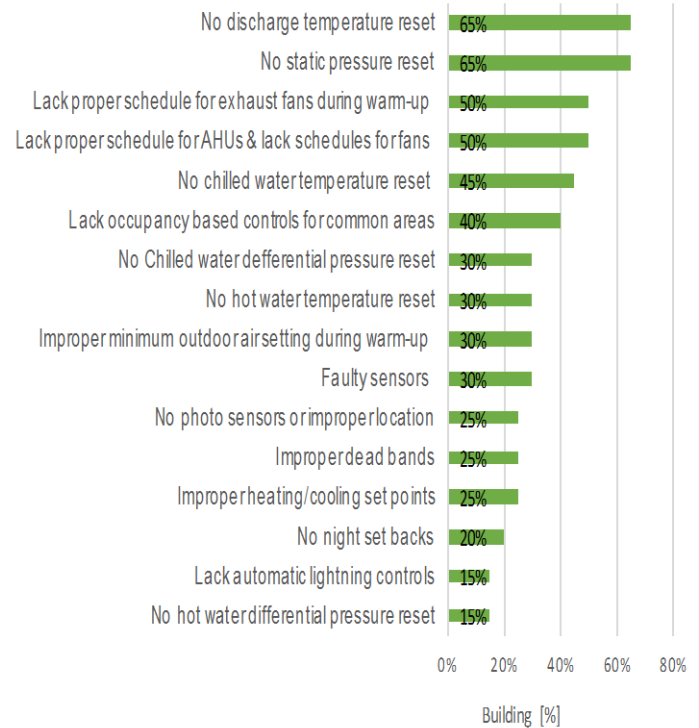
Figure 7. PNNL Meta-Analysis of 100 Commercial Office Buildings (2013-2015)

As many as 50% of the buildings in which re-tuning took place lack proper schedules for AHUs and/or lack schedules for exhaust fans running during warm-up mode; over 65% of the buildings do not use static pressure or discharge temperature reset on AHUs; over 30% of the buildings have one or more faulty sensors and/or improper minimum outdoor-air setting during morning warm-up, etc.
